# Ultrasonic Pole Testing

# Ultrasonic Pole Testing Report

Date: 5/23/2011  
 Property:  
 Pole Type: Steel, 7 Gauge, Round  
 Manufacturer: Imperial Poles  
 Dimensions: 26' tall from ground to fixture

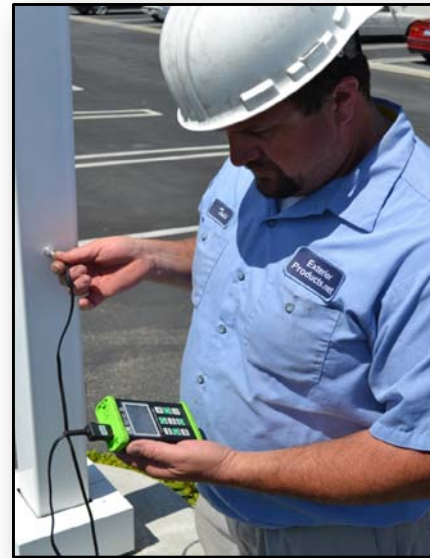
Latest- NDT Certified  
Ultrasonic Thickness  
Gauge

Positive Identification of  
Dangerous Corrosion
